NASA Technical Paper 1584

Lubrication and Wear Mechanisms of
Polyimide-Bonded Graphite Fluoride
Films Subjected to Low Contact Stress

Robert L. Fusaro

JANUARY 1980

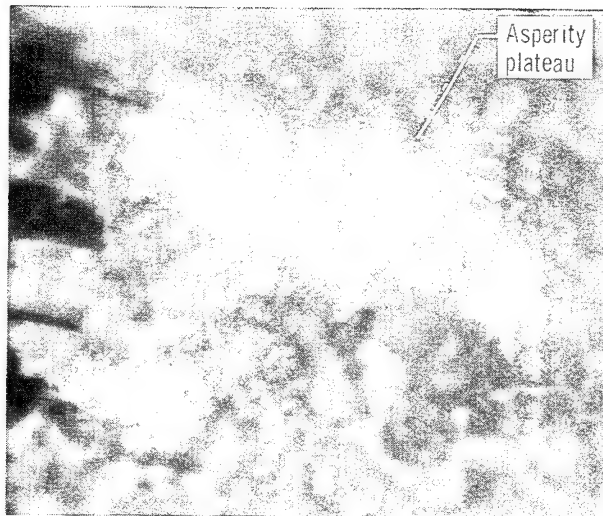
(a) Sliding interval, 1 kilocycle.

(b) Sliding interval, 15 kilocycles.

(c) Sliding interval, 60 kilocycles.

(d) Sliding interval, 250 kilocycles.

Figure 7. - High-magnification photomicrographs showing wear progression on polyimide-bonded graphite fluoride asperity plateau. Rider and disk substrate material, 440C HT stainless steel; load, 1 kg; estimated contact stress, 14 MPa (2000 psi); sliding speed, 2.6 m/sec; temperature, 25° C; atmosphere, moist air (10 000 ppm H₂O).

The wear progression of an individual film asperity is shown in figure 7 after sliding intervals of 1, 15, 60, and 250 kilocycles. The high-magnification photomicrographs show the truncation of the film asperity and its merging with other asperities as

truncation occurred. The plateau on the film asperity was very smooth and reflective; however, there were some very fine cracks and areas where the film has spalled from the plateau. High-magnification optical observation of the film wear track suggested that spalling of thin layers on the plateaus was the primary wear mechanism while sliding was on the film asperities (at least under the conditions used in this investigation).

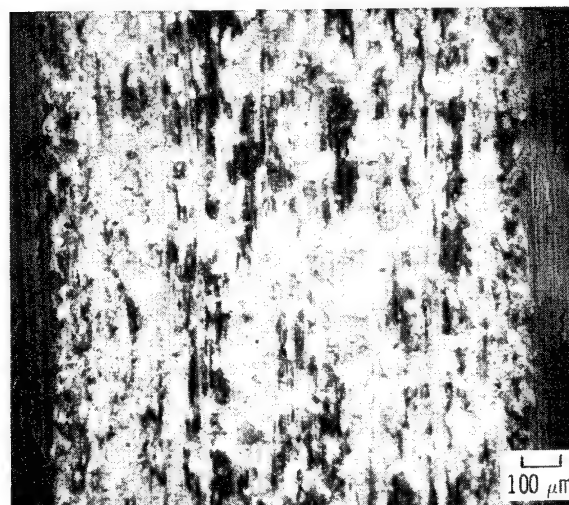
(a) Sliding interval, 1500 kilocycles.

(b) Sliding interval, 3500 kilocycles.

(c) Sliding interval, 6000 kilocycles.

(d) Sliding interval, 8500 kilocycles.

Figure 8. - Photomicrographs of wear tracks on polyimide-bonded graphite fluoride films after long sliding intervals. Rider and disk substrate material, 440C HT stainless steel; load, 1 kg; estimated contact stress, 14 MPa (2000 psi); sliding speed, 2.6 m/sec; temperature, 25° C; atmosphere, moist air (10 000 ppm H₂O).

After 500 kilocycles of sliding, the film asperities were worn away (fig. 3). As figure 3 shows, the rider continued to wear gradually through the film until the metallic asperities on the substrate were reached at approximately 3500 kilocycles of sliding. Figure 8(a) shows the film wear track after 1500 kilocycles of sliding, and figure 8(b) shows the film wear track after 3500 kilocycles of sliding. Very tiny bright spots can be seen in the film after 3500 kilocycles of sliding. These are the tips of the metallic asperities on the substrate.

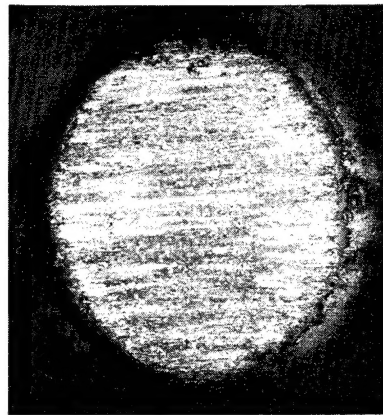
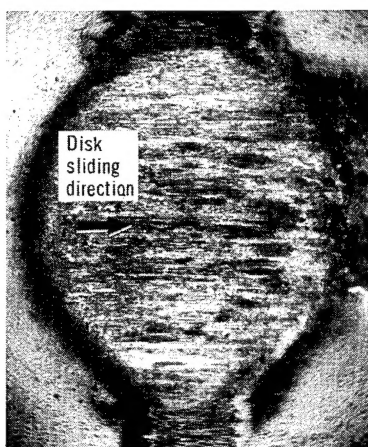
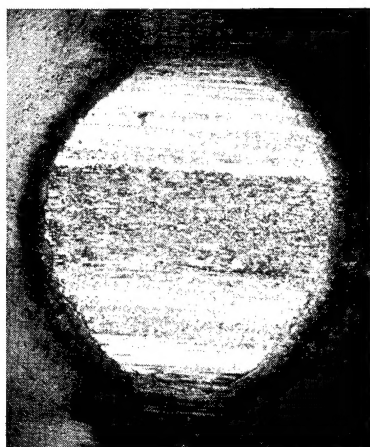
(a) Flat before sliding.

(b) Flat after 1 kilocycle of sliding.

(c) Flat after 250 kilocycles of sliding.

(d) Flat after 1500 kilocycles of sliding.

(e) Flat after 4500 kilocycles of sliding.

(f) Flat after 8500 kilocycles of sliding.

Figure 12. - Photomicrographs of 440C HT stainless-steel rider contact area after various intervals of sliding on polyimide-bonded graphite fluoride films. Disk substrate material, 440C HT stainless steel; load, 1 kg; estimated contact stress, 14 MPa (2000 psi); sliding speed, 2.6 m/sec; temperature, 25 °C; atmosphere, moist air (10 000 ppm H₂O).

A photomicrograph of the rider flat before sliding is shown in figure 12. Also shown in figure 12 is the same rider flat after sliding intervals of 1, 250, 1500, 4500, and 8500 kilocycles. Figure 12(b) shows that initially very thin transfer occurred on the rider flat. Figure 13(a) is a high-magnification photomicrograph of that transfer. Broad, colorful interference bands are visible. On continued sliding, the transfer to the rider gradually increased (figs. 12(b) to (d) and 13(a) to (c)). Comparing the friction trace of figure 2 with the amount of transfer suggests that the friction was lowest when the transfer was thinnest.

Thin transfer films were found on the rider after 6000 and 8500 kilocycles of sliding (figs. 12(f) and 13(d)); however, they looked somewhat different than the thin transfer films found after 1 kilocycle of sliding (figs. 12(b) and 13(a)). Interference fringes were only visible in the entrance of the rider contact area (fig. 13(d)); and the transfer in the contact area itself was milky colored, an indication that the transfer was thinner than the wavelength of light ($0.4 \text{ } \mu\text{m}$).
